PBY Catalina

Walk Around

By William Scarborough

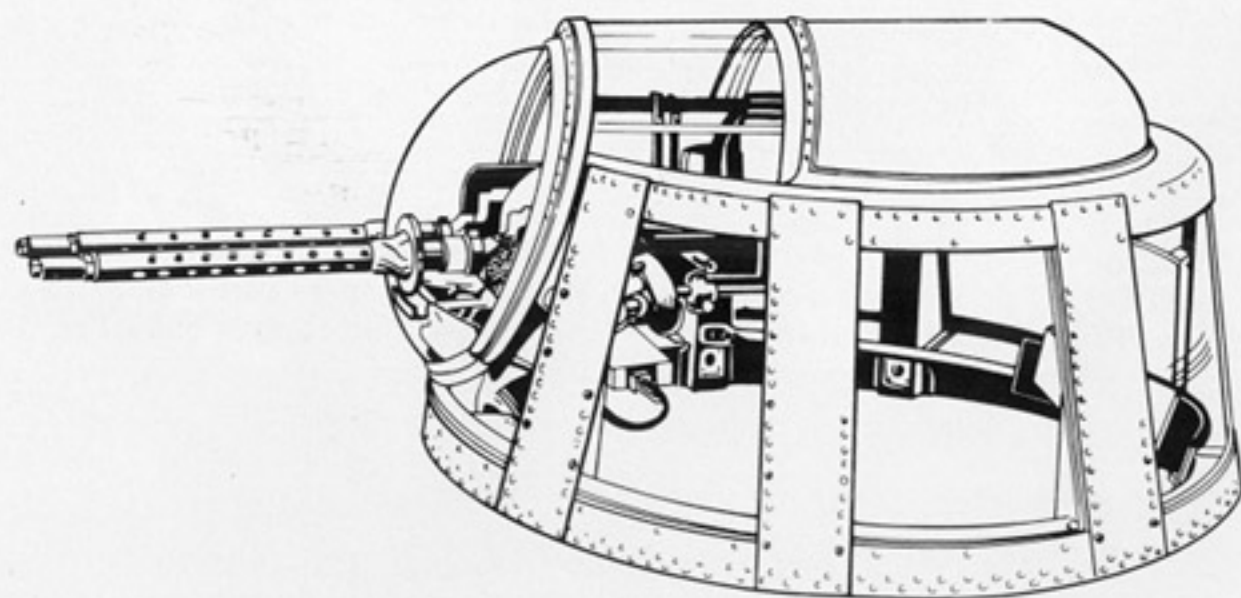
(Right) The "eyeball" turret modification was highly successful and well liked by PBY crews. It improved the bow guns handling, doubled the firepower of the position, and kept the gunner out of the weather. (Mike Bobe)

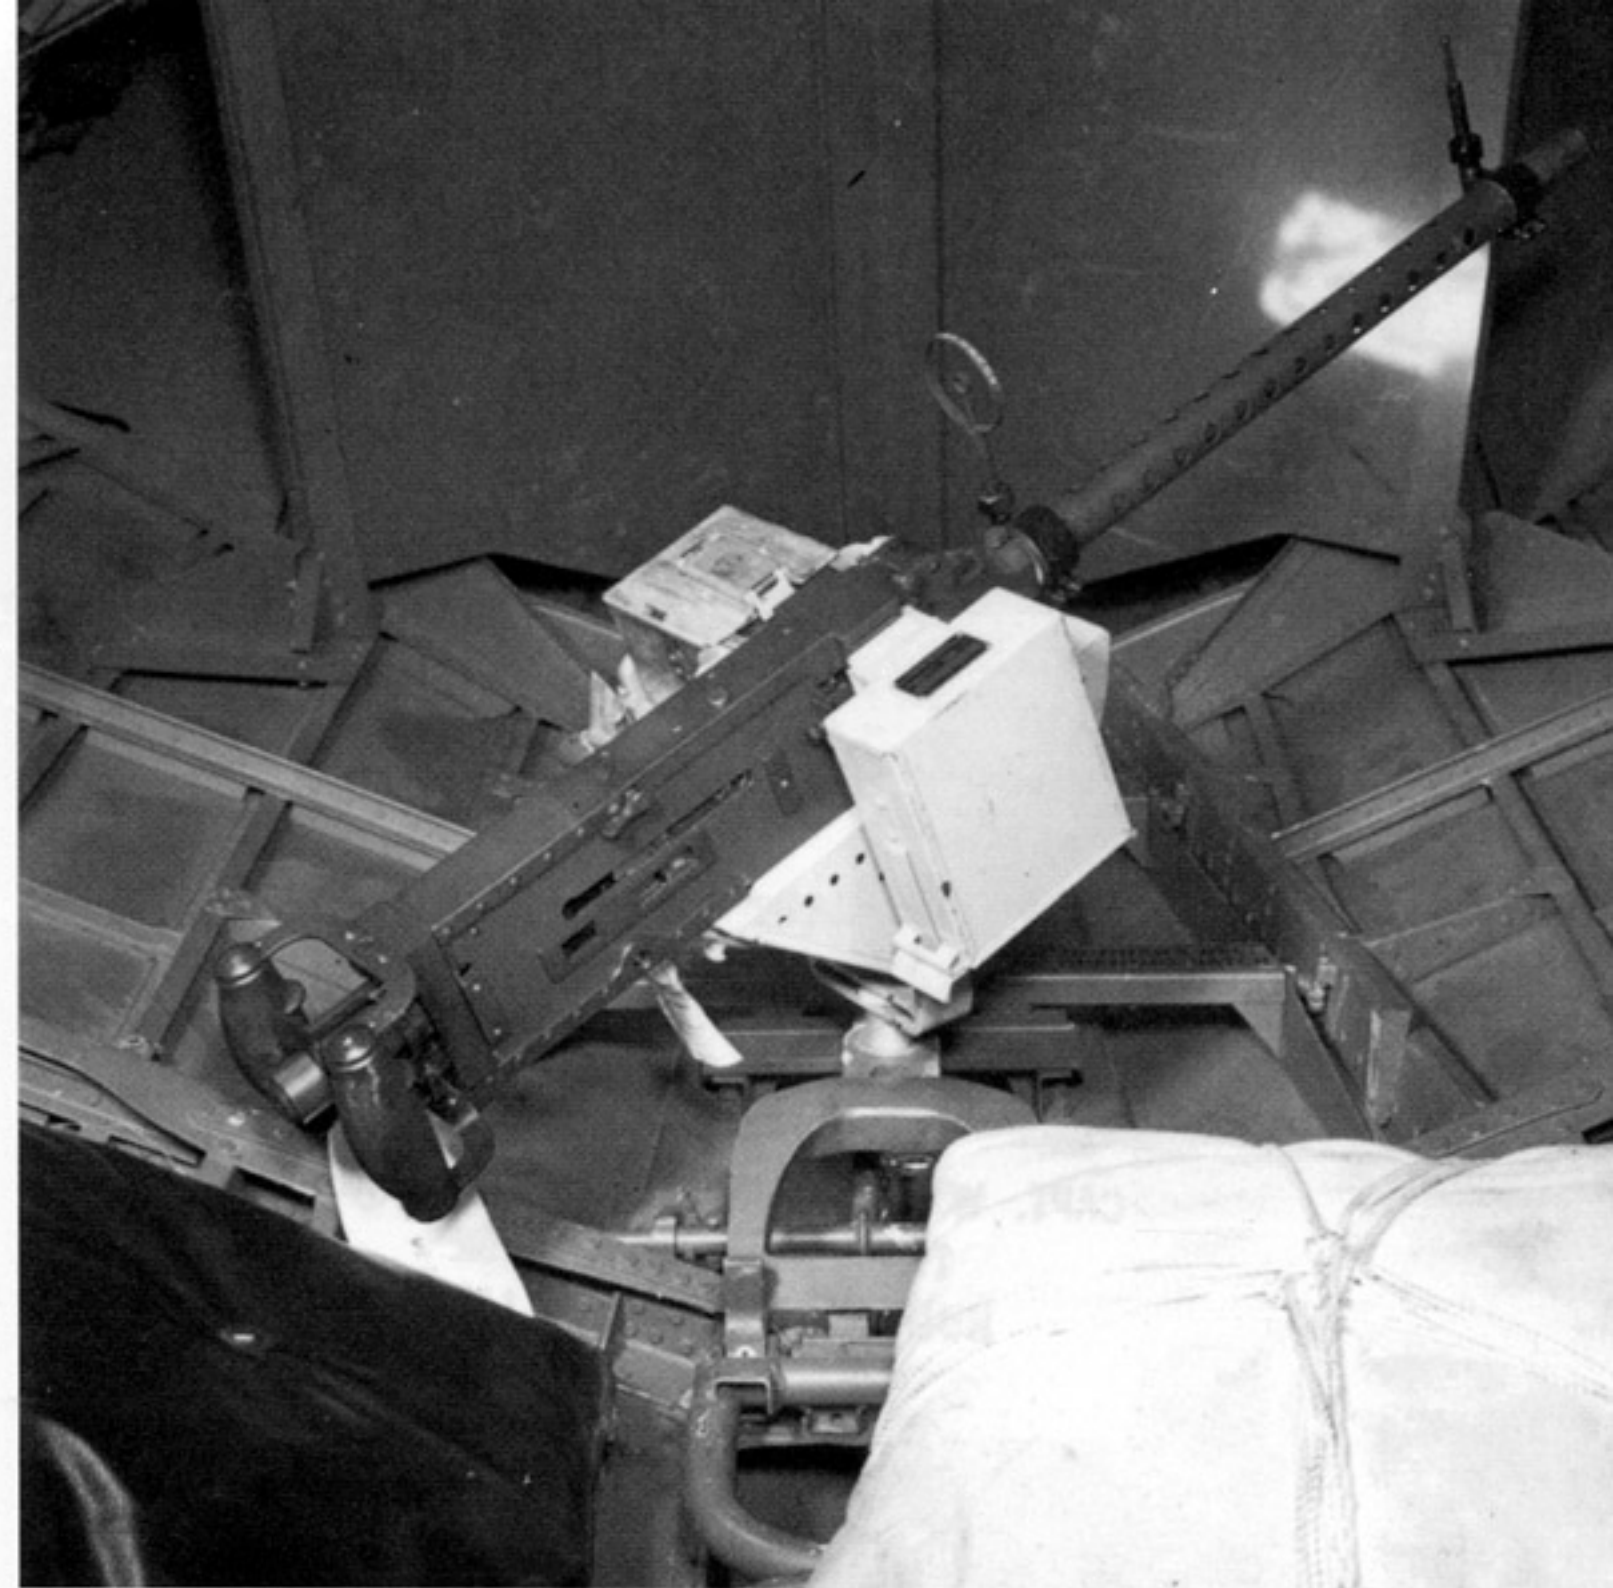
Tunnel gun position with the hatch closed and the gun in the firing position. The ammunition can is on the left side, belt link container on the right and spent cartridge container below gun. An armor shield is to the rear of the hatch. The White bag is ballast carried while engaged in a ferry flight with less than a full crew. (USN)

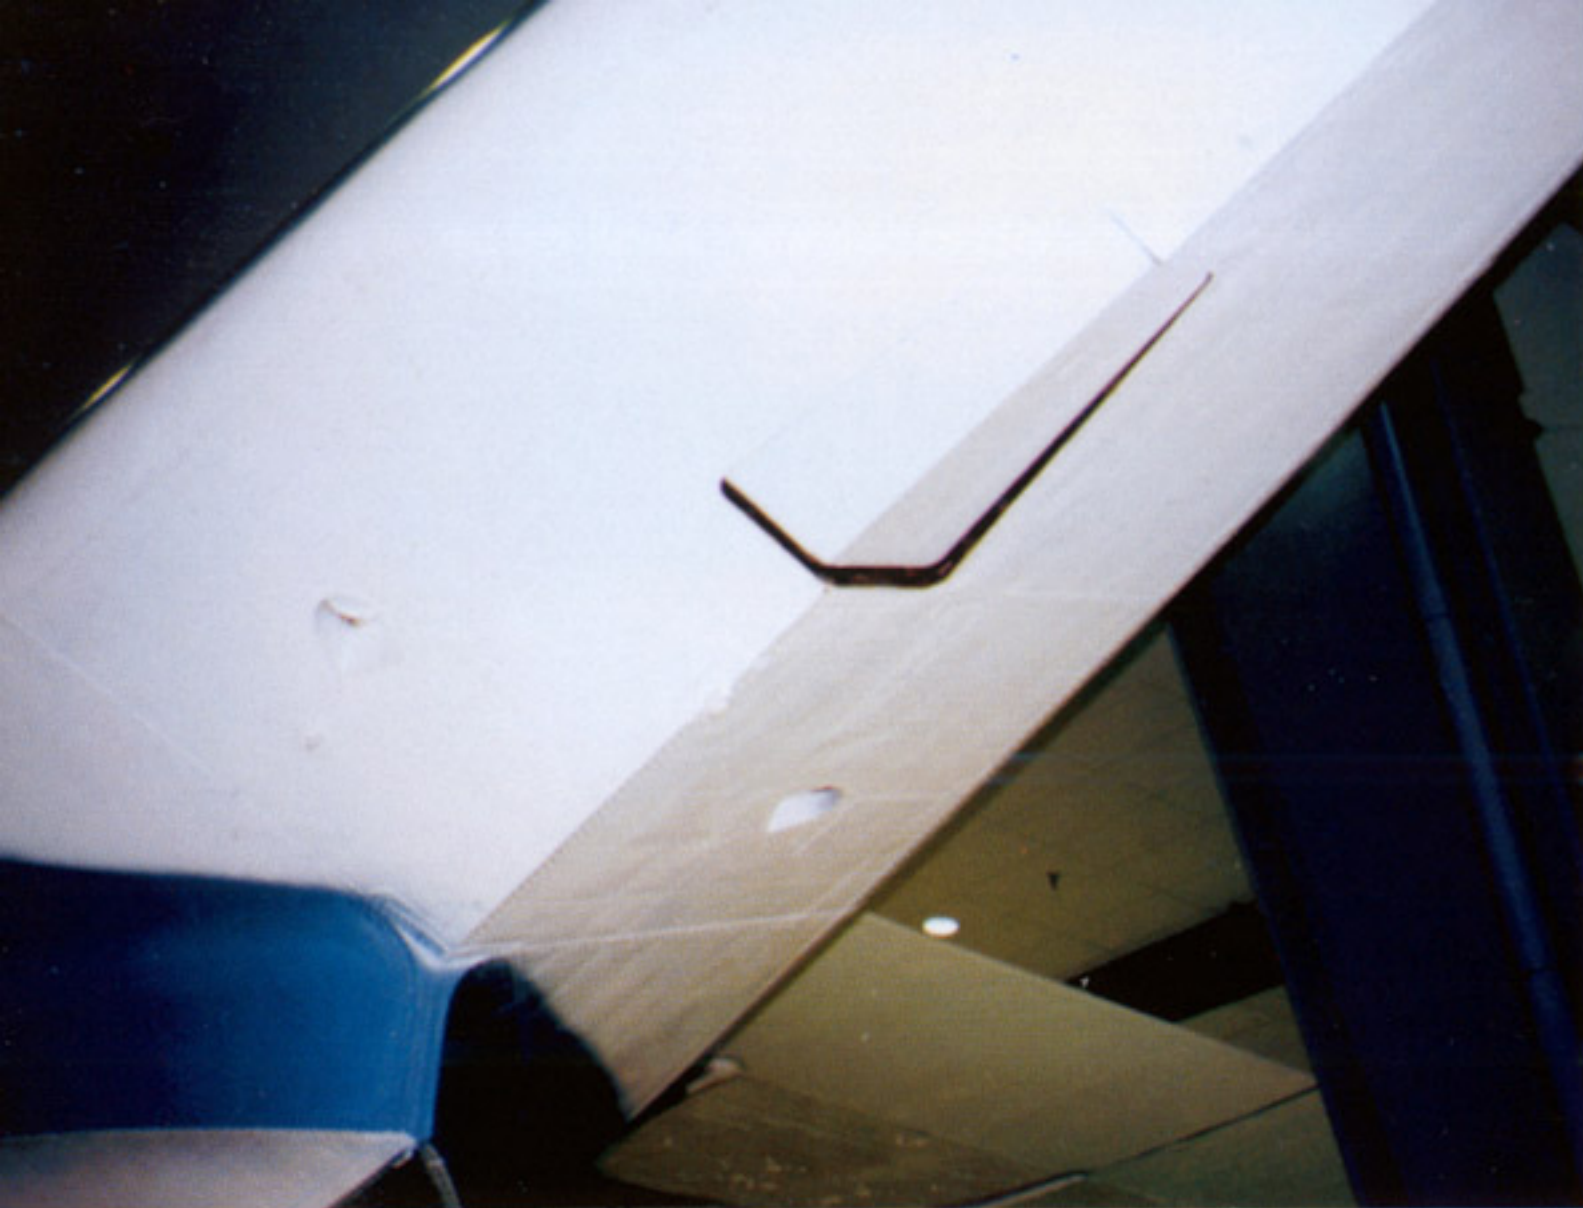
The tunnel gun position was located in the bottom rear hull. The gun position was sealed with a removable hatch (shown partially open). The two semi-circular openings forward of the hatch are parachute flare ejection ports. This PBY-5 (BuNo 08317) is currently on display at the National Museum of Naval Aviation in Pensacola, Florida. (WES)

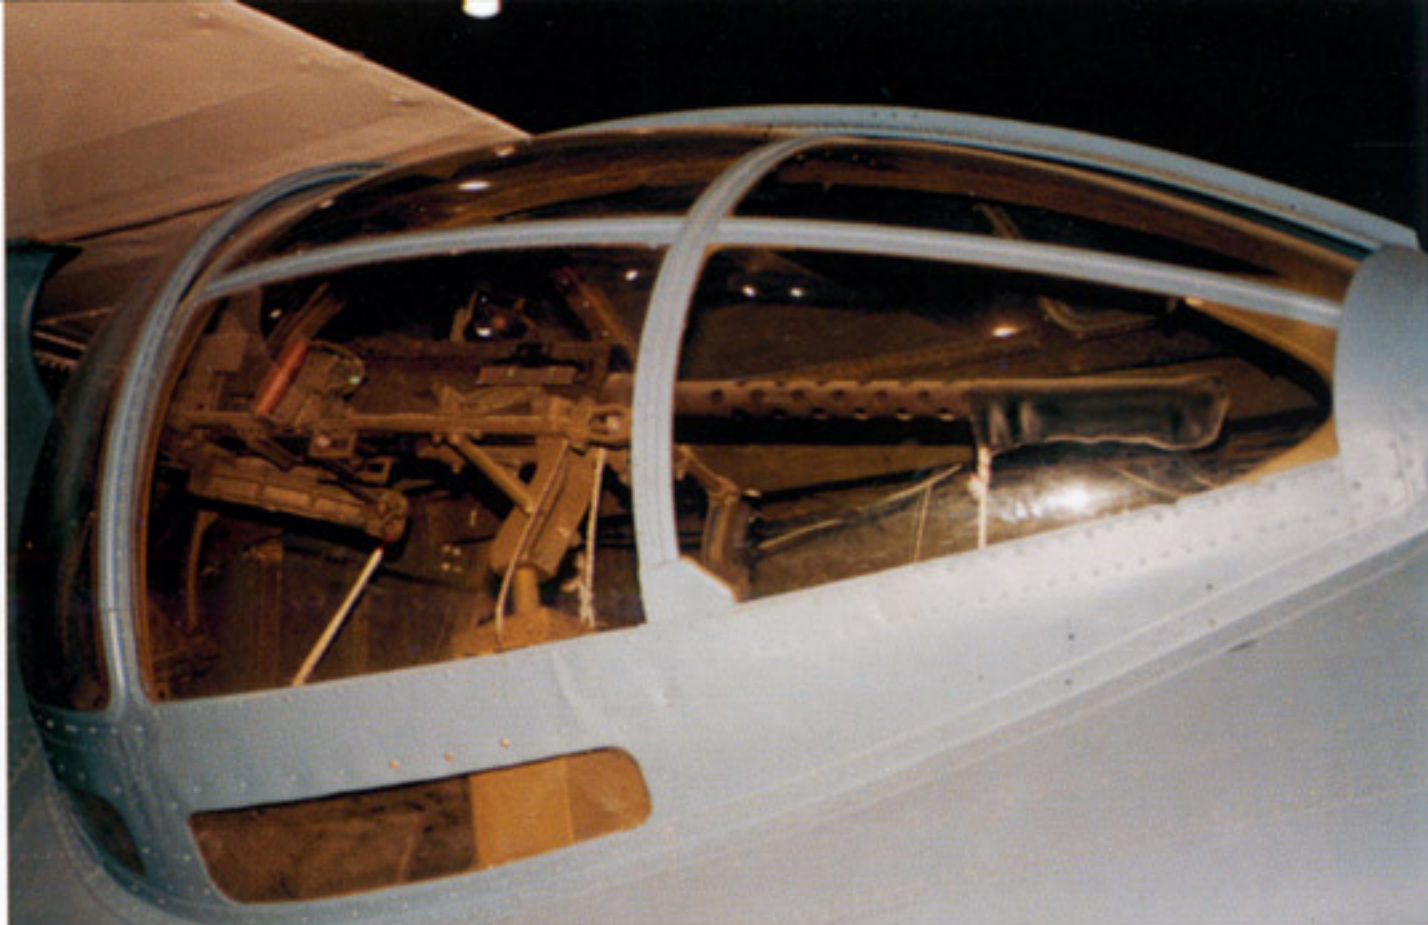
The port waist gun position with the blister in the closed position and the gun stowed. When not in a combat zone, the waist position was normally kept closed since the open hatch created a considerable amount of drag. (B. Ryle)

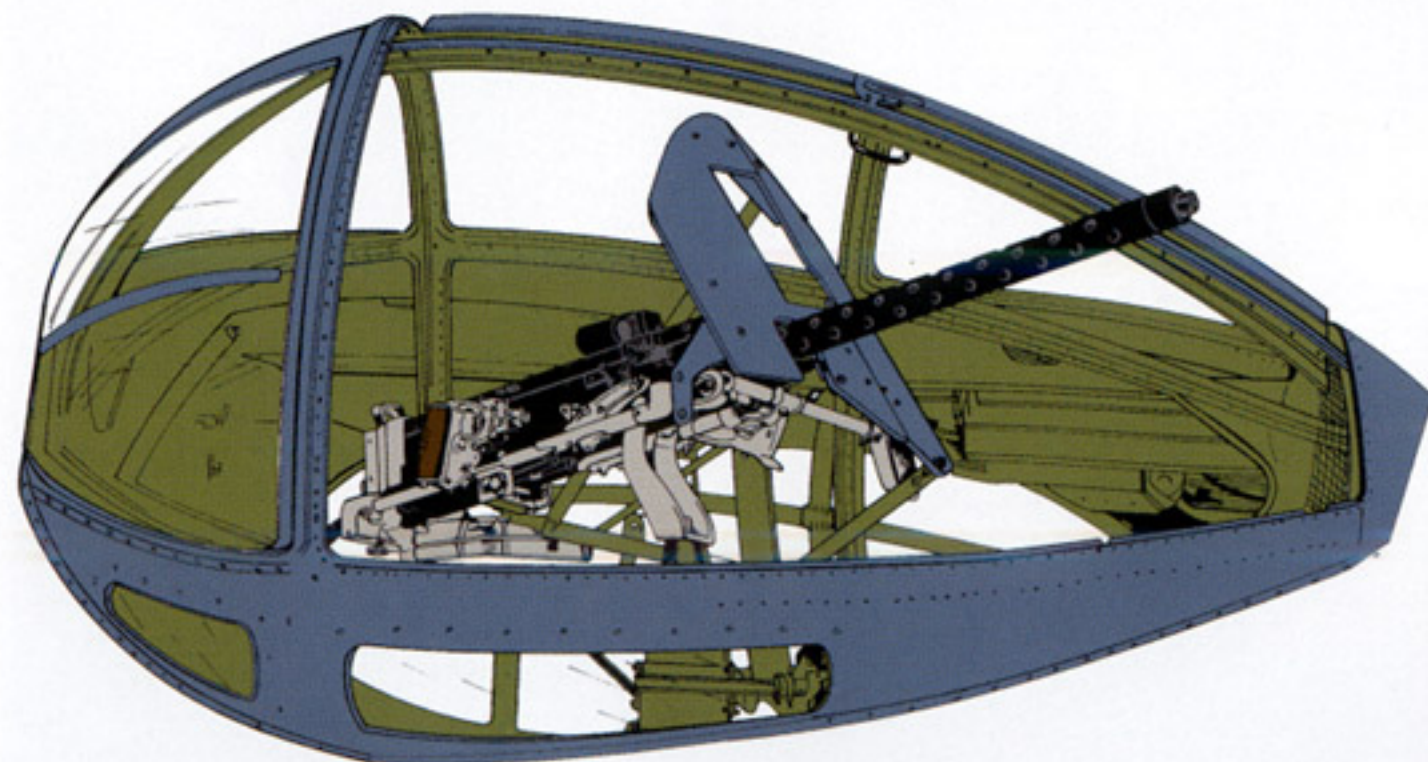
Mid-War Gun Mount With Mk 9 Reflector Sight And Armor

(Right) The waist positions gave the gunners an excellent field of fire. The waist positions also served as the main entrance for crewmen into the aircraft via a boarding ladder which could be attached to the fuselage just to the rear of the blisters on either side of the aircraft. This PBY-5 is on display at the National Museum of Naval Aviation. (Mike Bobe)

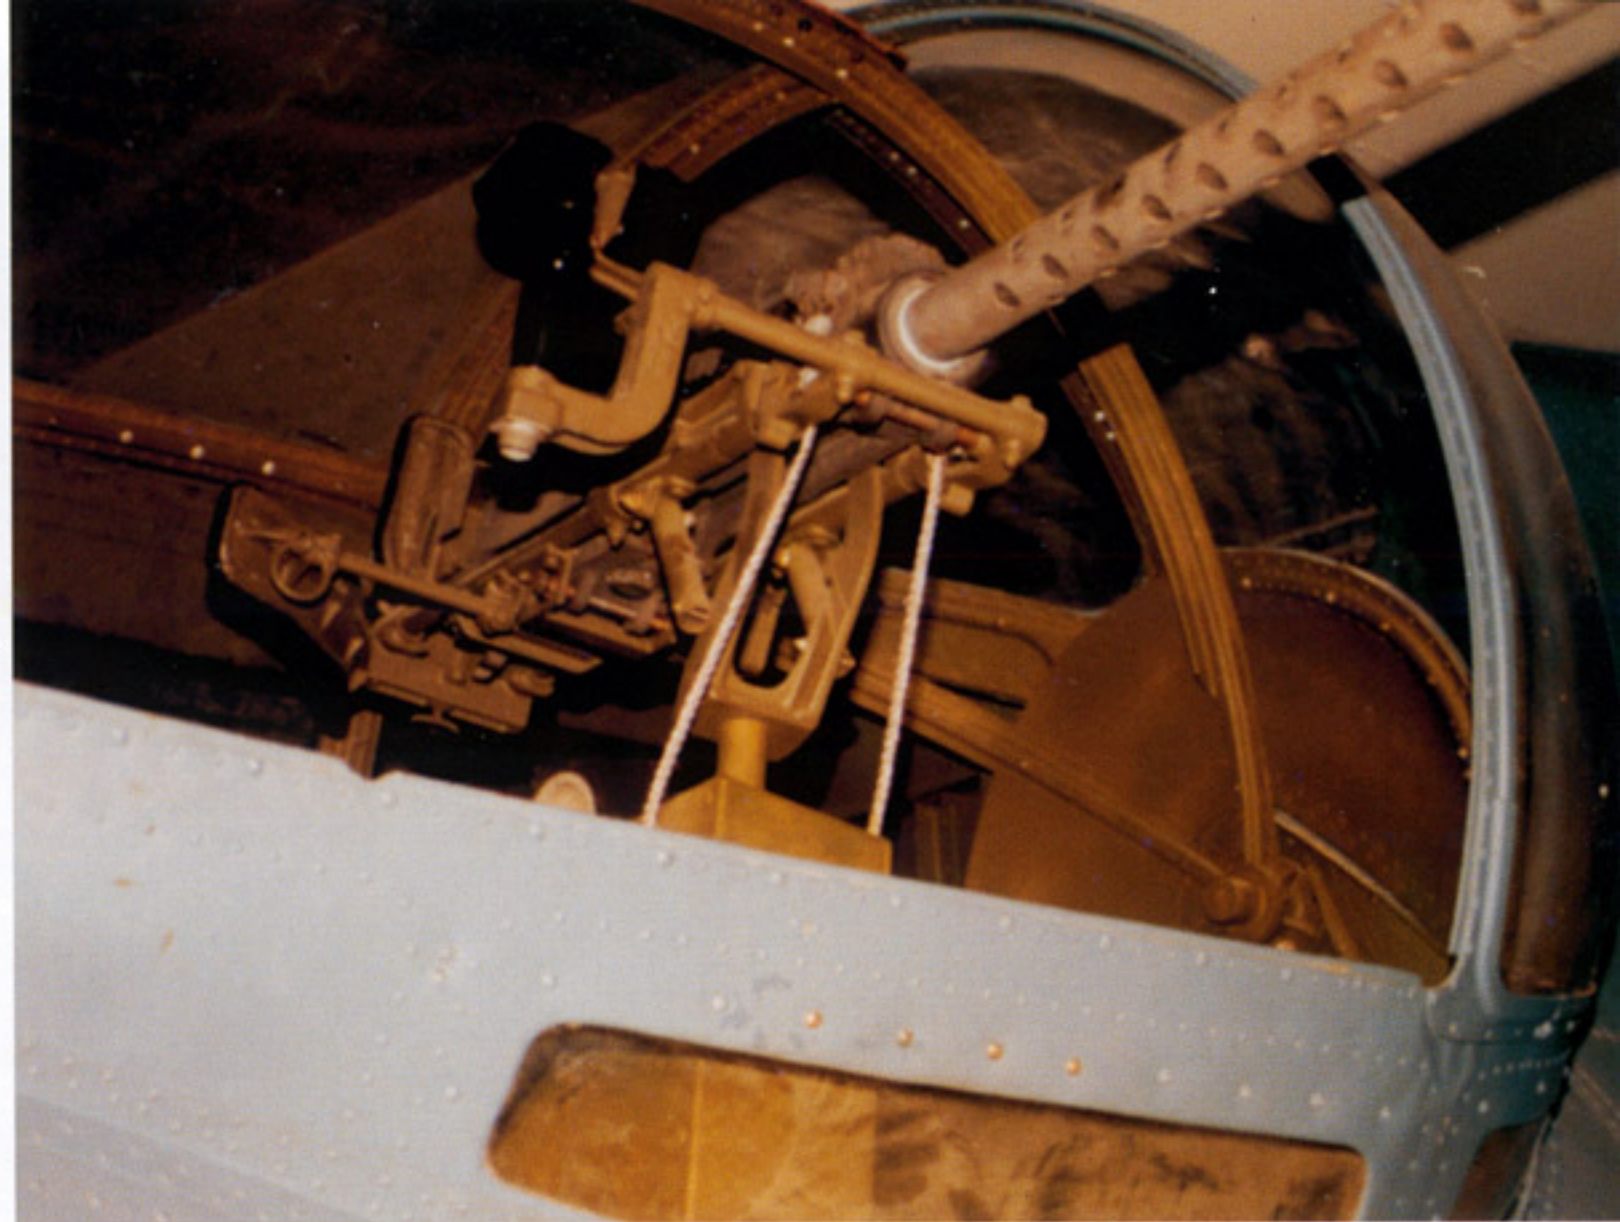
The starboard waist .50 caliber machine gun on the USAF Museum's OA-10A (serial 44-33879) in the firing position. The White cords are anchoring gun for display; however, the gun mount on this restored Catalina appears to be incomplete. (B. Ryle)

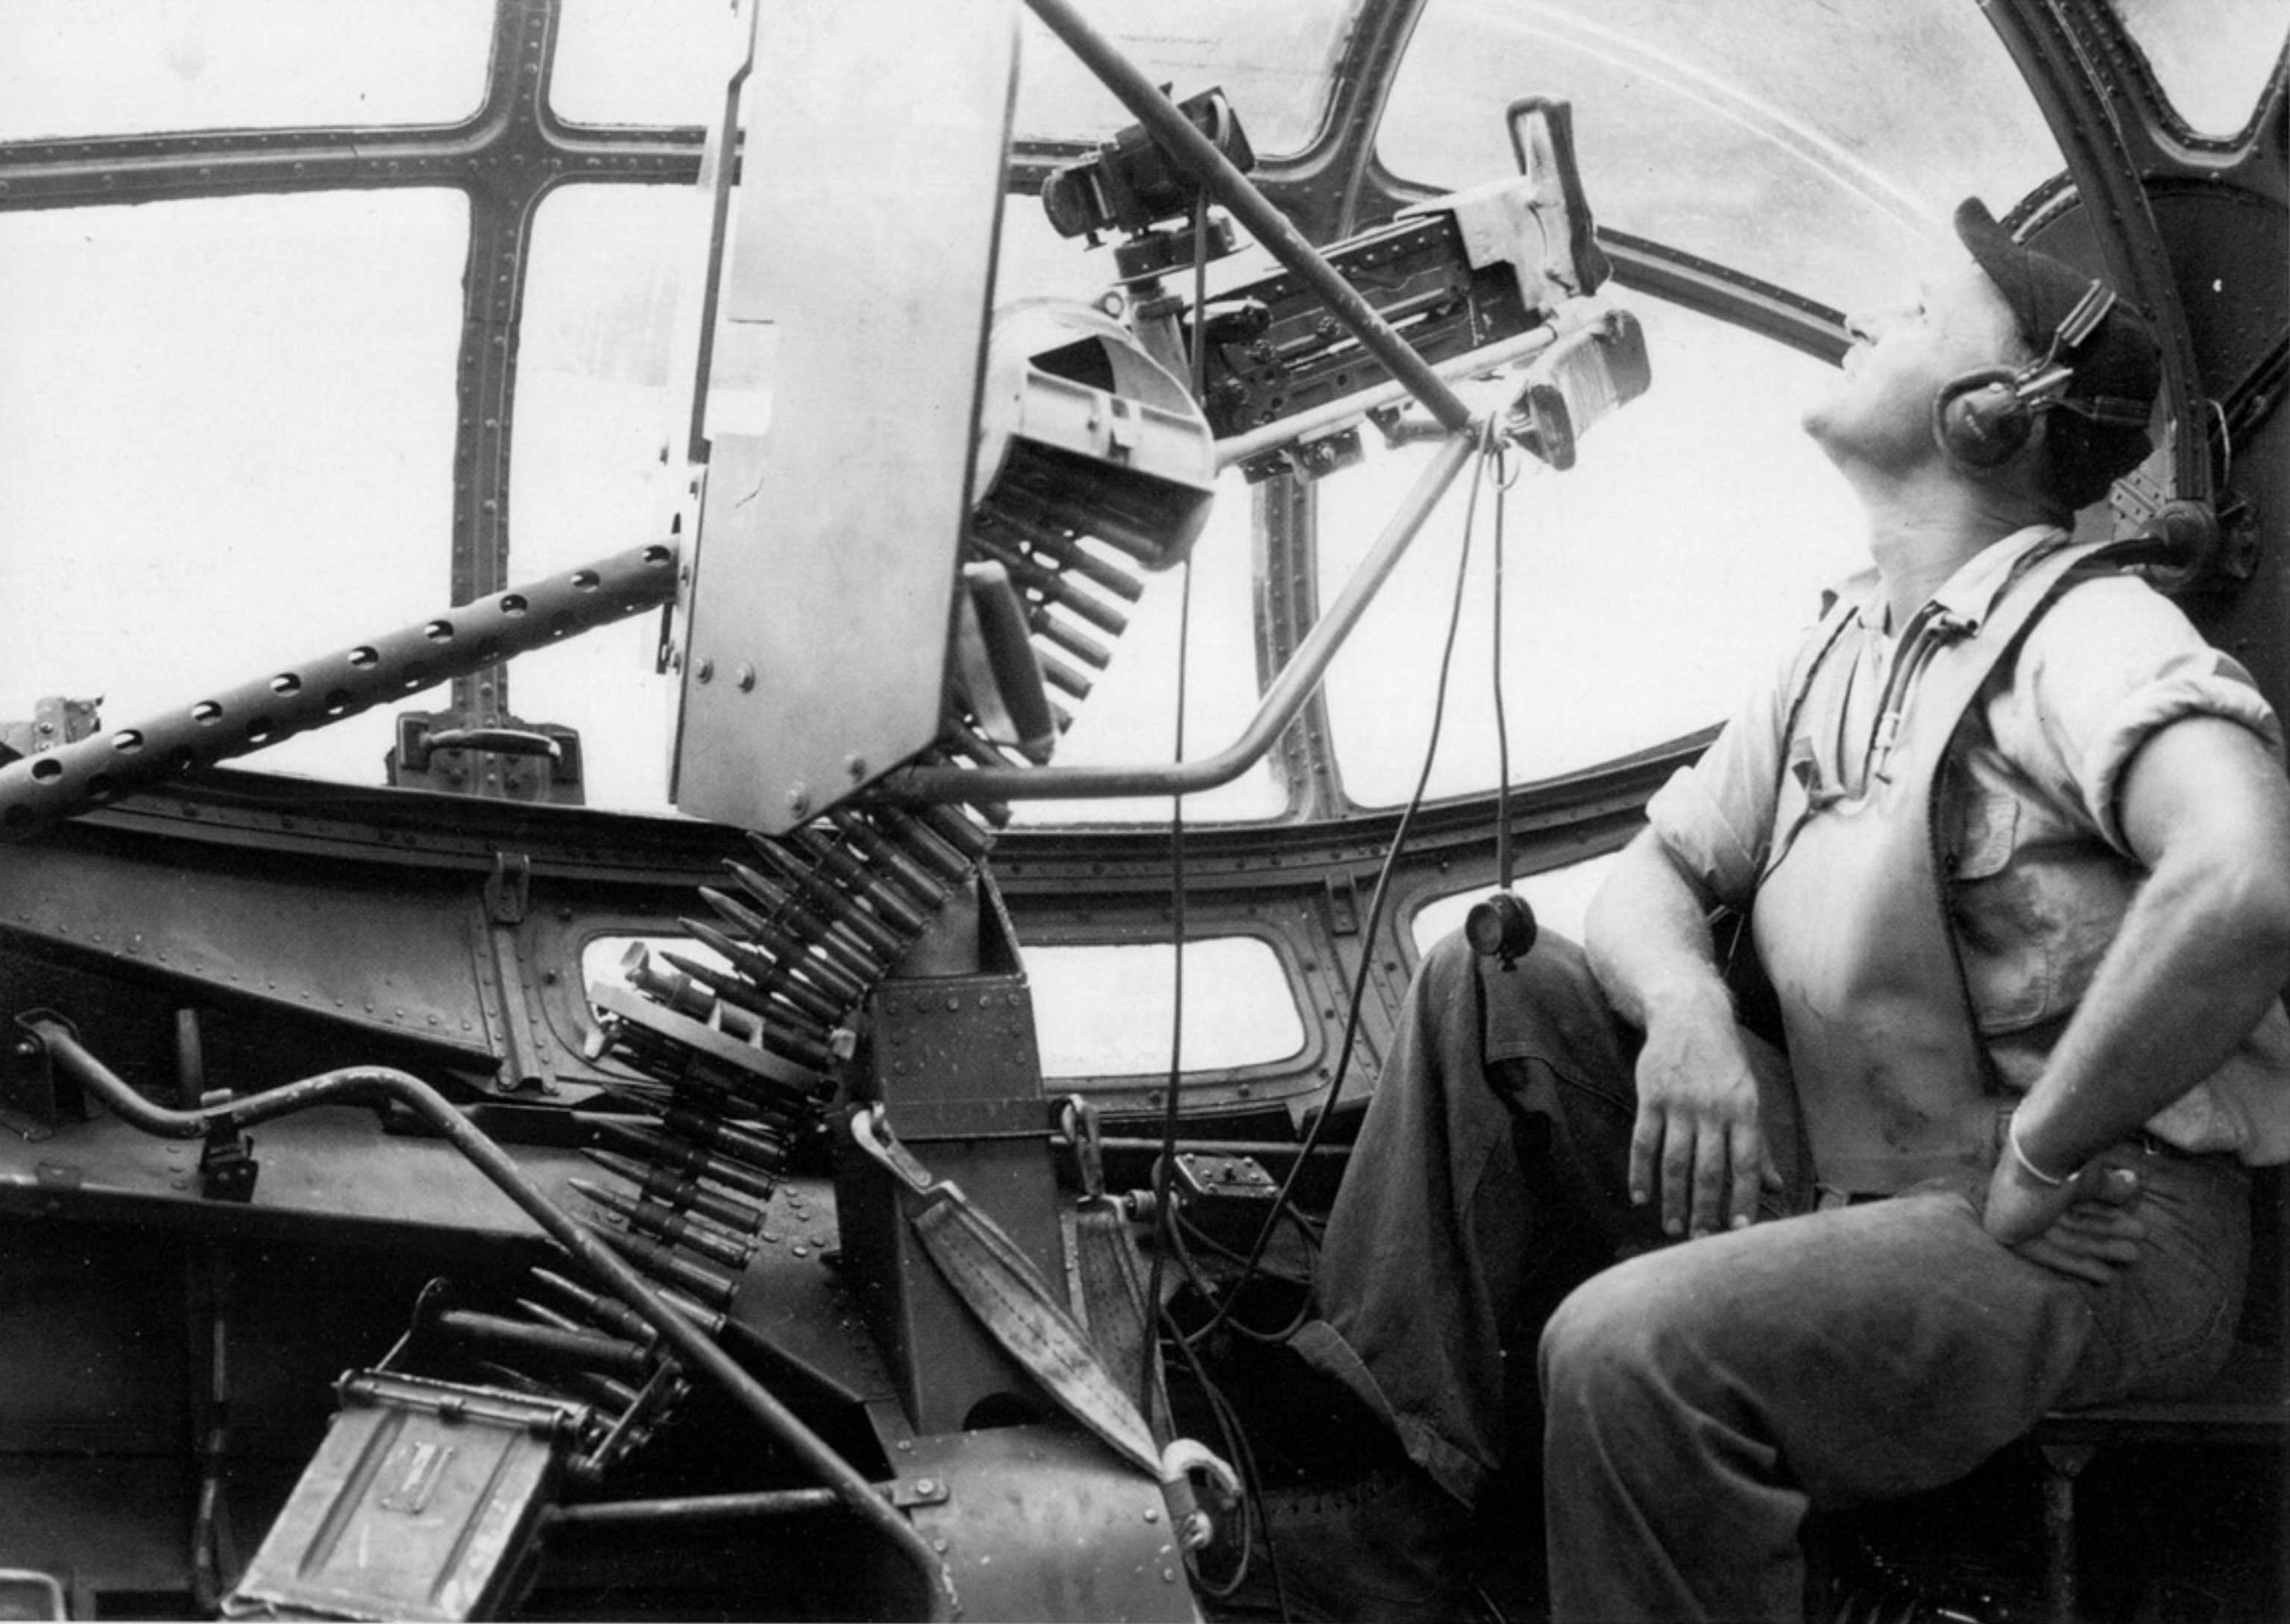
The port waist blister gunner of a VP-81 PBV-5, based on Bougainville, in the Solomons Island Chain, keeps watch while on patrol during January of 1944. The Browning .50 caliber machine gun was equipped with an armor shield, Mk 9 reflector sight and power-assist ammunition feed from a central magazine on the deck. The bent rod at the lower left is a protective device that kept the gunner from firing into the tail of the aircraft when the blister was open. (USN via National Archives)

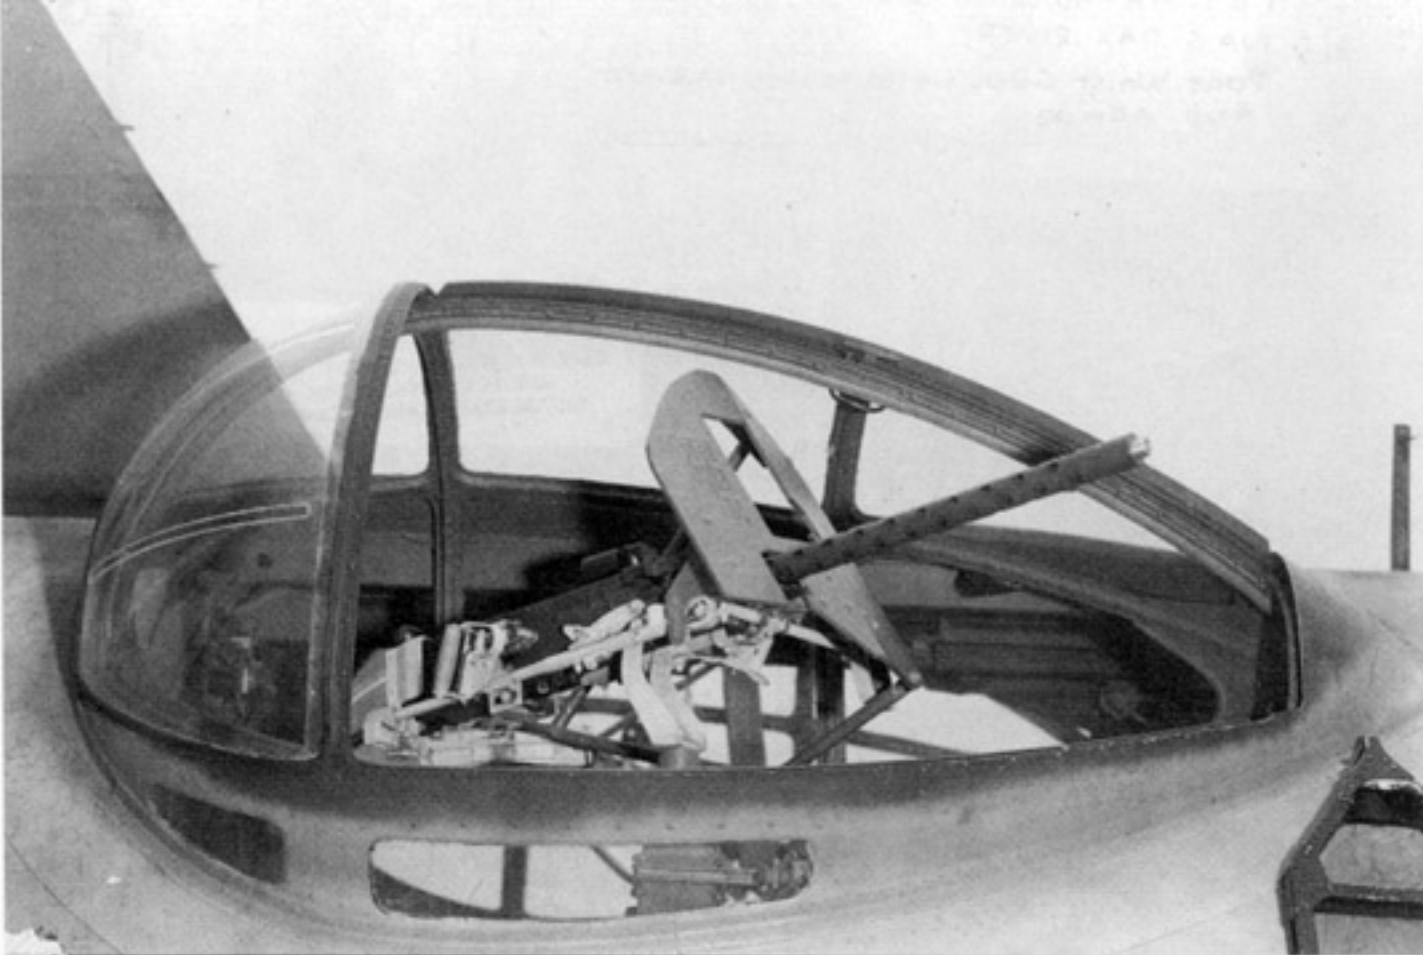
The port waist gun position on PBX-5A (BuNo 48262) with the gun in the firing position and the blister window open. (USN)

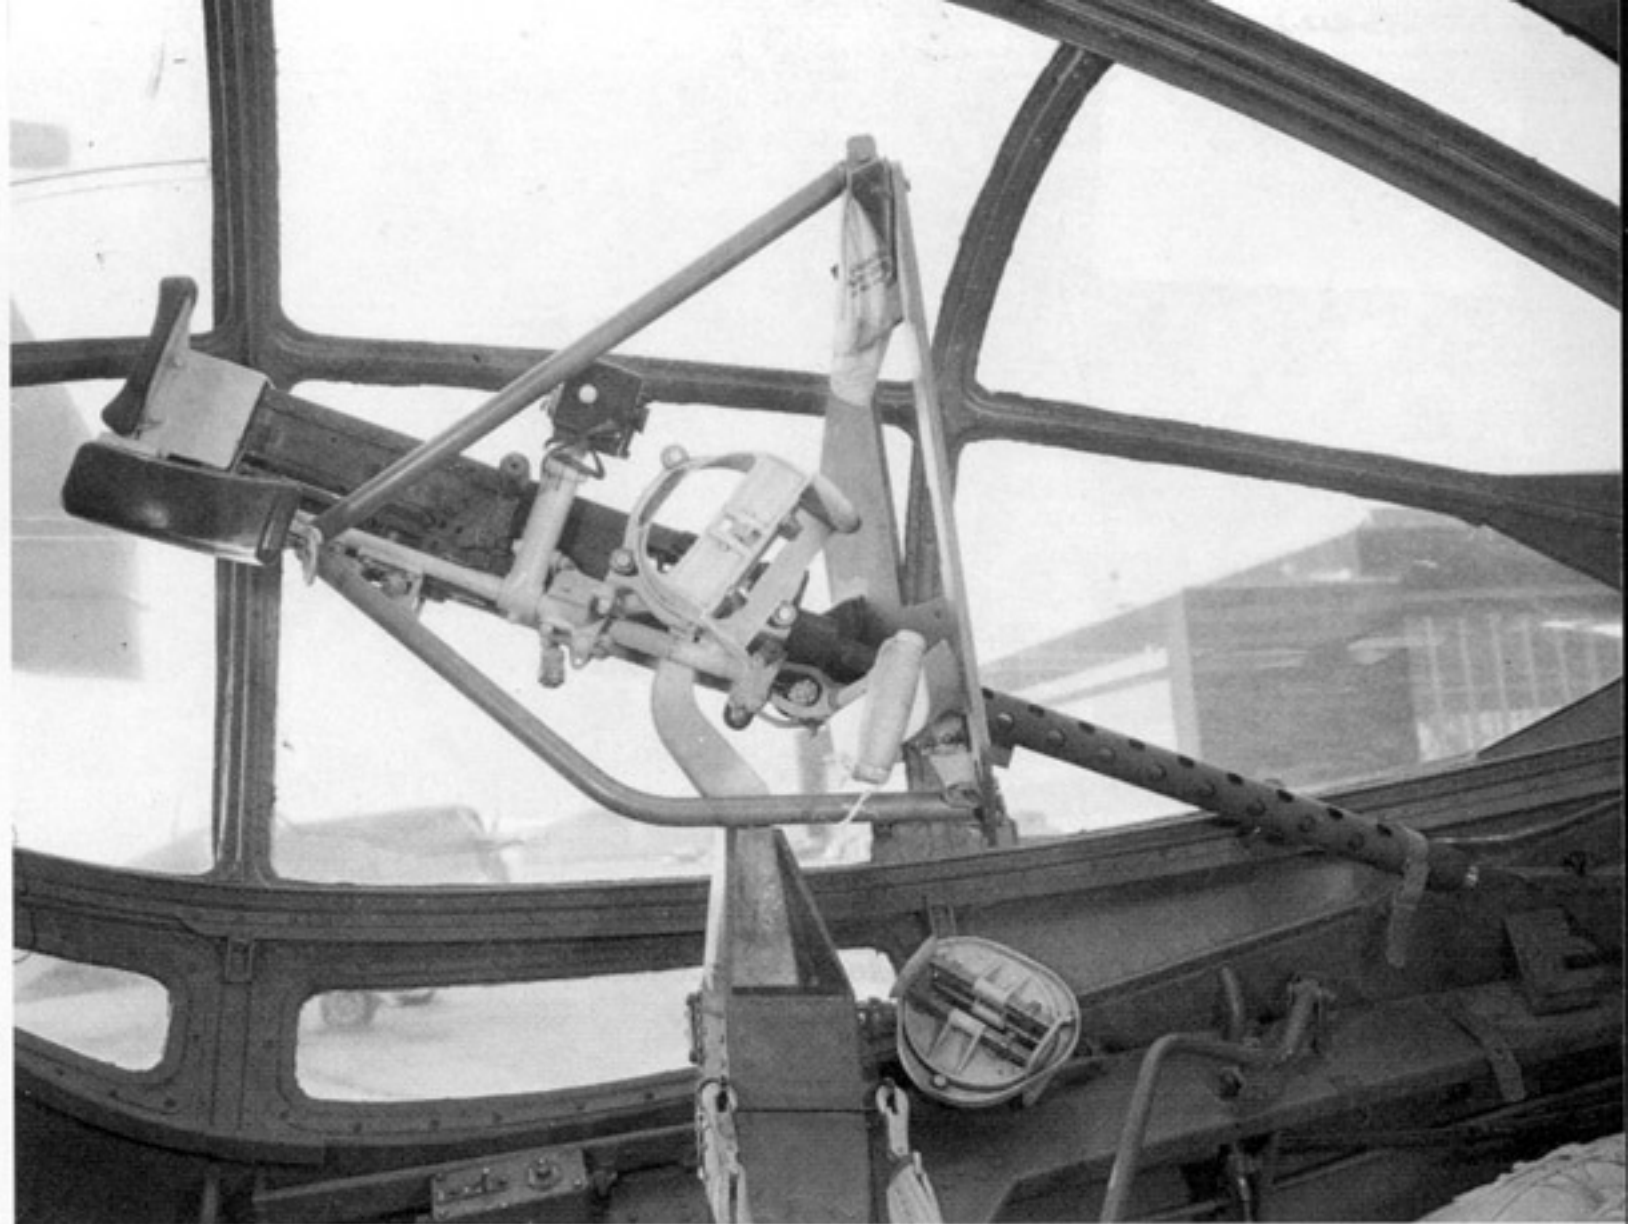
(Right) The starboard waist blister gun position of PBX-5A BuNo 48262 at NAS Patuxent River, Maryland on 23 December 1943. The .50 caliber air cooled Browning machine gun was fitted with a Mk 9 reflector sight, armor shield, and power-assist ammunition feed. The round object below the gun is a guide for the continuous belted ammunition which was fed from a central magazine on the deck between the mounts. (USN)

The starboard blister gunner of a PBX-5/-5A with the gun in the firing position. Early .50 caliber installation used a telescopic gun sight, which was very inaccurate and difficult to use. It was replaced by the much improved Mk 9 reflector gun sight. Most PBX variants used the Browning M2HB air-cooled .50 caliber machine gun as standard armament in the waist positions. The Browning .50 was the standard American heavy machine gun of the Second World War period and flexible mounts were used on most bombers, both in the Navy and U.S. Army Air Corps. (CAC)

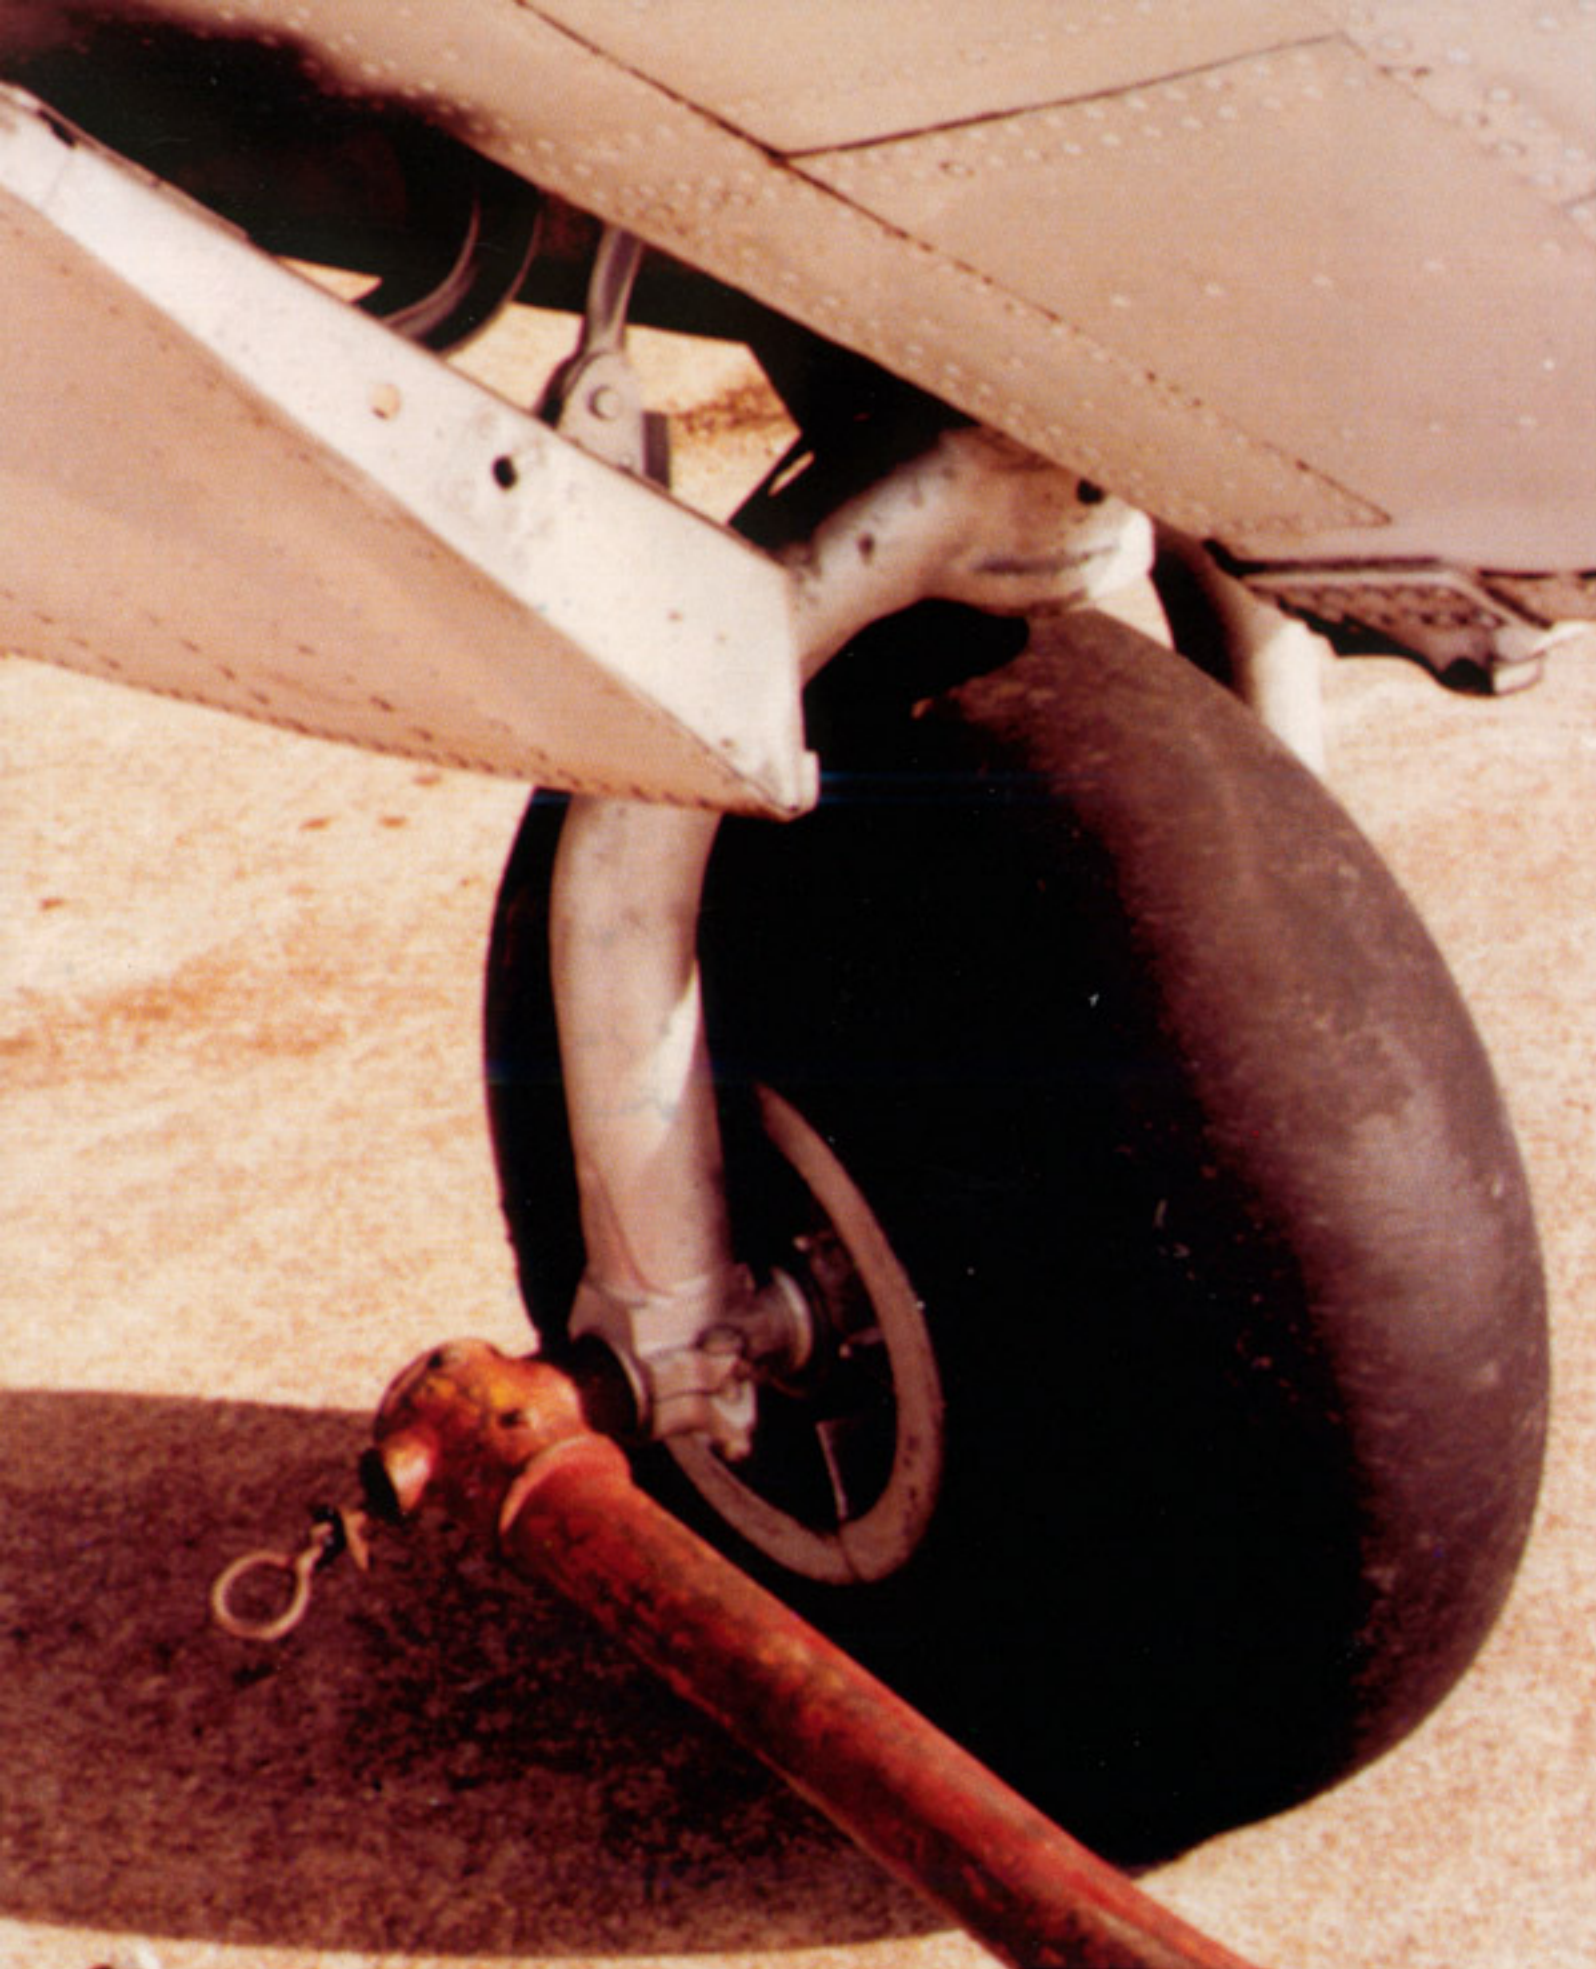
The nose wheel of a PBY-5A with a nose wheel tow bar in place. Security of the nose wheel doors was critical. On water landings and takeoffs, the doors could come open if not properly locked. At high speeds, an open door could cause loss of control or a water loop with significant damage or loss of the aircraft. (Ross Creed)

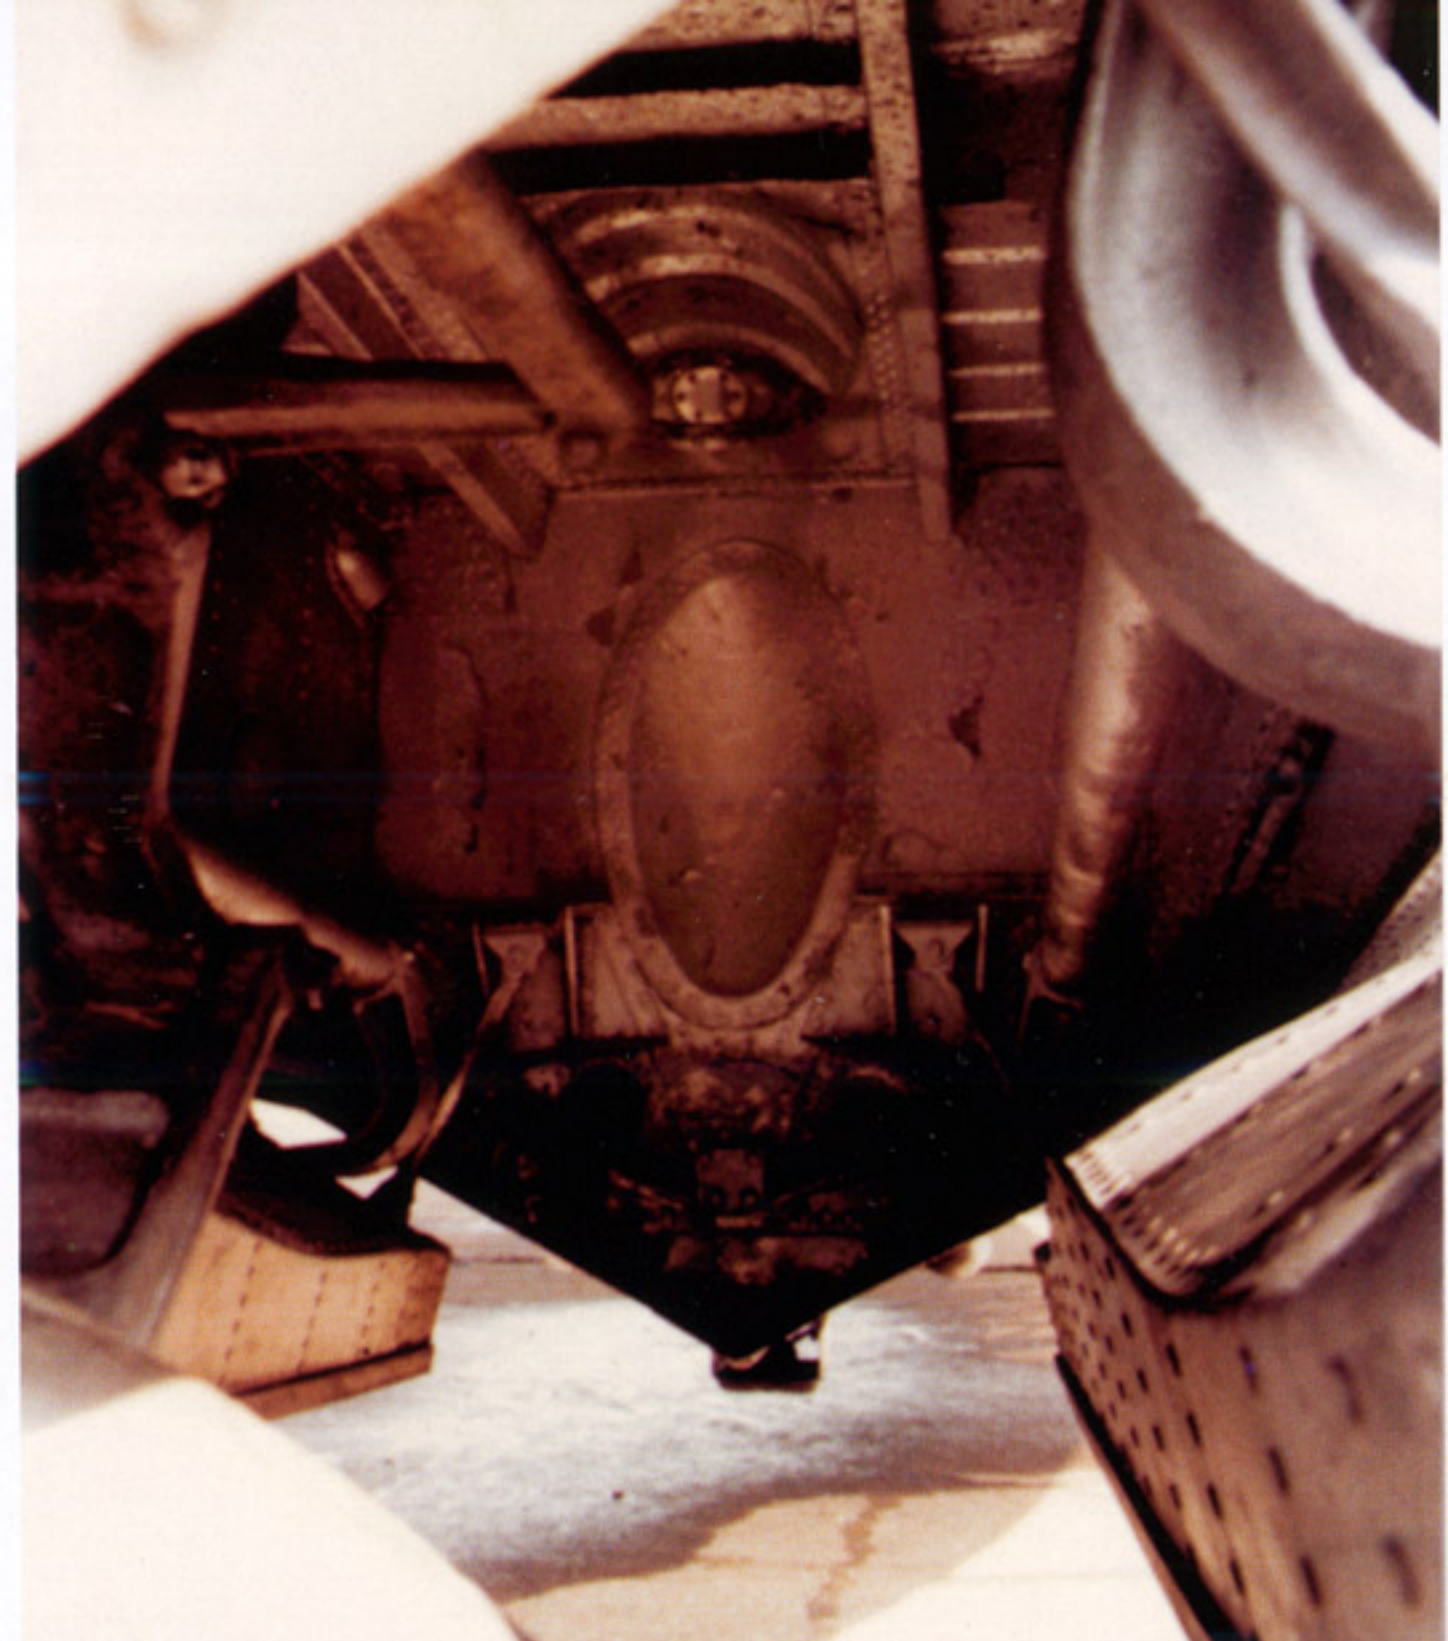
The nose wheel well of a PBY-5A. The two large vent holes in the lower rear bulkhead were a drain, after takeoff, for any water trapped in the wheel well. (Ross Creed)
